THE INSPECTOR GENERAL
Greenville-Spartanburg-Anderson SC
1-800-626-2888
www.theinspectorgeneral.net

Confidential Inspection Report
2011 Harbor Bay Dr
Greenville, SC 29607

January 25, 2012

Report: 1210XXX00-inspection 2 **Address:** 2011 Harbor Bay Dr

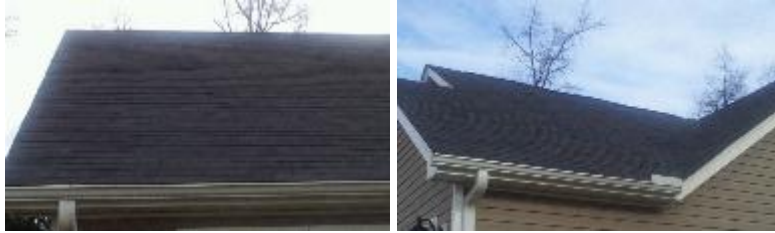
OK	MM	RR	FR	NR	
<input type="radio"/>	<input type="radio"/>	<input type="radio"/>	<input checked="" type="radio"/>	<input type="radio"/>	Shingles are curling and show a loss of their mineral granule coating. A licensed roofing contractor should be called in to make further evaluation and to repair or replace as needed.
<input type="radio"/>	<input type="radio"/>	<input type="radio"/>	<input checked="" type="radio"/>	<input type="radio"/>	The roof is warped somewhat at the right side of the garage. Refer to attic framing comments.

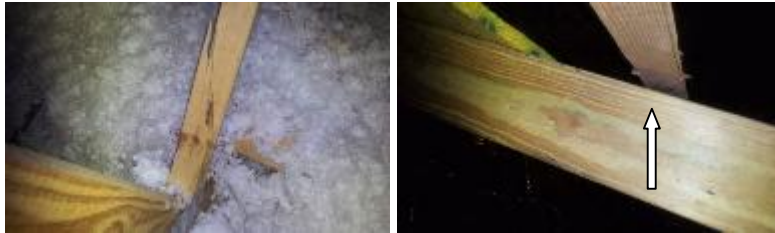
5.9 Structure:	<input type="radio"/>	<input type="radio"/>	<input checked="" type="radio"/>	<input type="radio"/>	<input type="radio"/>	One of the truss webs is cracked towards the bottom and to the left of the attic access. This may be related to the warped sheathing observed at the garage roof. Truss system is installed in the attic area that is used to support the roof decking and transmit the roof load to the walls below. Engineered trusses used in modern construction can provide additional wider open span distances than is common with traditional wood rafter or ceiling joist systems. The truss roof is a specialized system which is intended for site-specific engineering, of which verification of the correct installation is beyond the scope of this inspection, and due to the design plans were not available to the inspector at the site. The roof construction was most likely approved by your local codes authority and may or may not meet their requirements. If further information or structural analysis of the roof system is desired, an engineer who specializes in roof construction should be consulted prior to close of property. Trusses- Lateral bracing observed for supporting the truss system, Sheathing- The roof decking material is oriented strand board sheathing. The builder installed ply clips when installing the sheathing to prevent the sheathing from sagging at the joints.

Some uplift observed and nails pulled loose at the bottom chord of the trusses located above the garage where the roof warp was observed.
