Report: 1210XXX00-inspection 2 **Address:** 2011 Harbor Bay Dr

RE: 2011 Harbor Bay Ct
Taylors, SC 29687

SUMMARY OF AREAS REQUIRING FURTHER EVALUATION

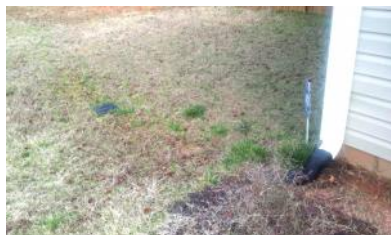
2.13 Site:

Catch basin observed. Recommend review with the seller regarding the operation, care and maintenance required. The building site is sloped. Evidence of poor drainage observed. Drainage appears to be slow around the foundation at the left side. Suggest observing during rainfall and taking corrective action as needed.

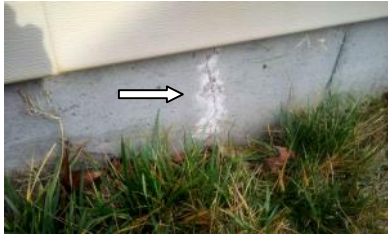
3.5 Materials & Gen Condition:

Building slab is constructed with poured and formed concrete. Condition - Typical settlement cracks noted. In slab construction the inspector is unable to determine the extent of the cracks at the covered interior areas.

Recommend sealing all cracks and monitoring for further movement.

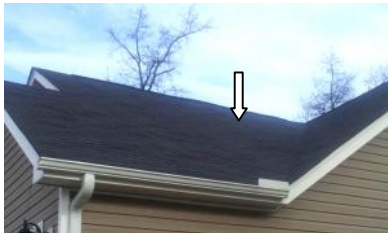
5.4 Roof Covering Condition:

Shingles are curling and show a loss of their mineral granule coating. A licensed roofing contractor should be called in to make further evaluation and to repair or replace as needed.

The roof is warped somewhat at the right side of the garage. Refer to attic framing comments.

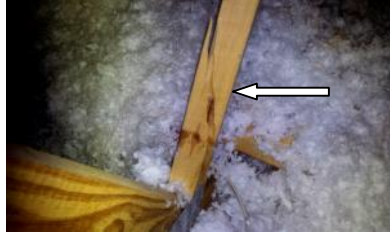
5.9 Structure:

One of the truss webs is cracked towards the bottom and to the left of the attic access. The upper piggy back trusses are pulling loose at the bottom chord attachment to the lower top chords. This may be related to the warped sheathing observed at the garage roof. If further information or structural analysis of the roof system is desired, an engineer who specializes in roof construction should be consulted prior to close of property. Trusses - Lateral bracing observed for supporting the truss system.

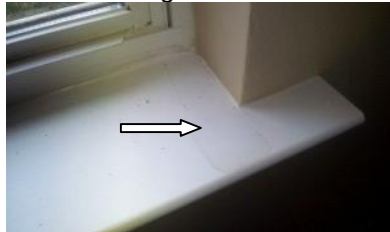
12.13 Master and Other Bedrooms:

Water staining observed at the sill/wall of the left rear bedroom. Recommend for review or repairs as needed.
