## **Confidential Inspection Report**

**21 Pleasant Avenue  
Greenville, SC 29607**

**Prepared for:  
Mr. and Mrs. Home Buyer**

November 30, 2011 10:00 AM.

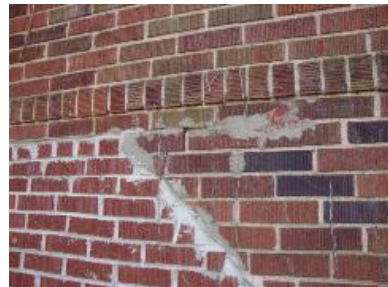
- Materials & Condition: OK MM RR
- Minor settlement cracks are noted at the rear where opening for former garage door altered. A hole in the brick was observed at the left side exposed the wood frame needs repair to prevent water intrusion.

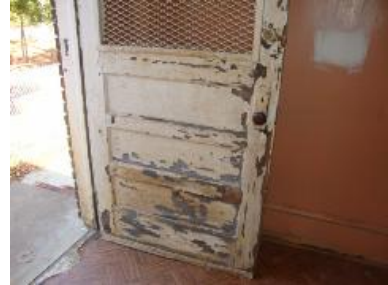
- Wood, panel type door, with glass. Damage viewed will peeling and possible lead base paint. **Observations-** Significant rot is noted at the lower portion of the doorframe. A qualified trim carpenter should be called to make further evaluation and repairs as needed.

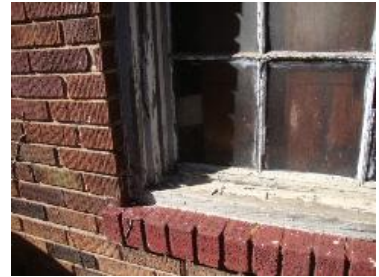
Major areas of peeling paint and possible lead base paint are seen. Windows need scraping and repainting to retard ongoing deterioration from the elements. Cracked window panes noted at many locations. Some screens are missing or damaged. Windows need major repair or most likely complete replacement.

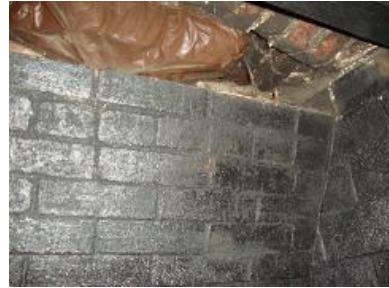
- The inspection is limited to the visible portions of the fireplace flue. Drop light, mirrors, and smoke testing are not a part of the inspection. Visibility is limited due to material stuffed in the smoke shelf below the flue. Further investigation is recommended, by a qualified professional chimney sweep prior to purchase of home. The fireplace flue was not checked from the top side. The inspector did not climb on to the roof or could not get to the chimney top. The chimney does not appear to have an interior flue liner which is a safety concern; investigate further.

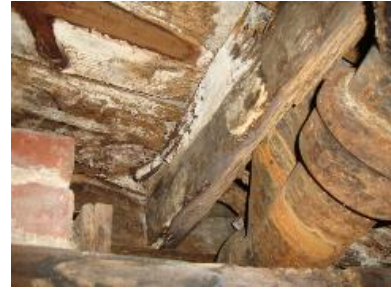
- 
- 
- Under floor support beams are wood of 2x10 full dimension. The main beam is made of layered dimensional lumber sandwiched together creating a built-up beam and ledger strips to hold the joists in place. Some joist bearing is on nails only without ledgers which can cause settlement or movement; corrections recommended. The main beam is in a condition that warrants replacement or repair. Moisture damage noted at the front sill under the dining room. Active wood insects possibly due shelter tunnels observed. Infestation damaged wood and moisture damaged wood observed. Please refer to a licensed termite and moisture professional for further review and treatment as needed. This type of service or evaluation is beyond the scope of this report. Refer to licensed framing contractor for review and repair of the basement/crawl space framing. Some of the framing is concealed by plastic ceiling material,

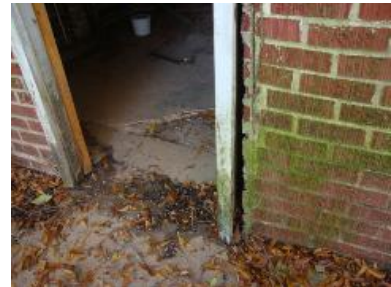
- Outside Entry Doors:*    The outside entry door/frame to the walkout section of the basement is loose and not secured to the wall and needs repair.

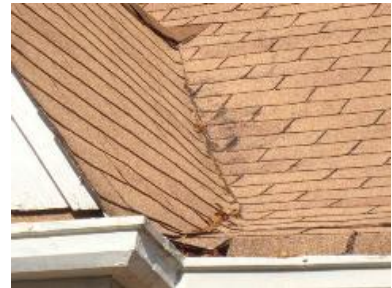
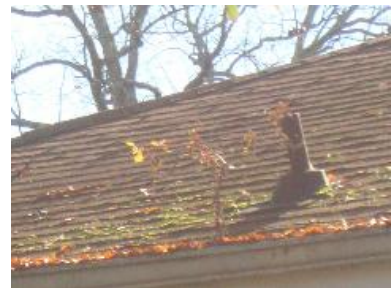
Roof covering may be approaching the end of its normal life expectancy. This roof is the point in its life where leakage can be expected to occur over the next few years. Evidence of past and current leakage observed. Cracking of shingles and loss of granular surface are the result of long term weathering and an advanced shingle age. Felts are showing through, The roof has been patched at some areas. A licensed roofing contractor should be called in to make further evaluation and to repair or replace as needed.

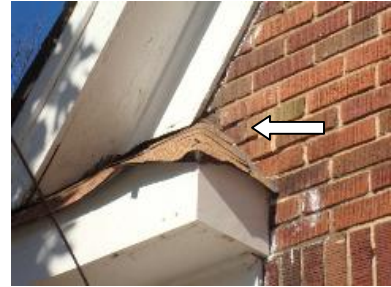
Metal. Rubber, The potential for water entry is present due to worn or missing flashing components. Recommend maintenance as needed.

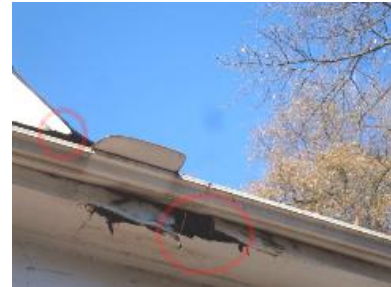
- Soffits and overhang materials are wood. Deterioration at overhangs noted. Major repairs are needed to prevent ongoing deterioration.

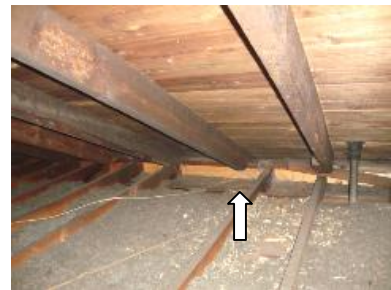
Rafters bear improperly off center of a single top wall plate that would be doubled in modern construction. This is causing the wall support at the top to sag.

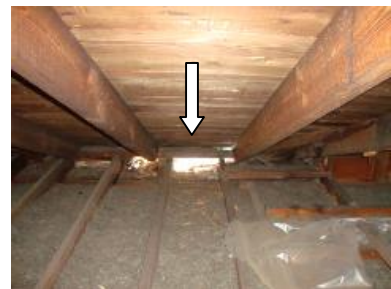
Open holes and decay observed at the eave areas.

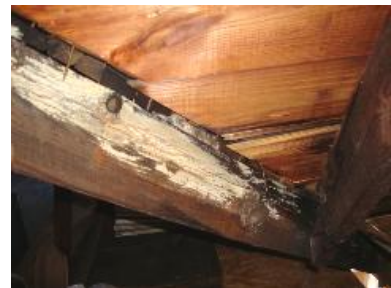
Rafter decay from roof leakage observed near the front porch.

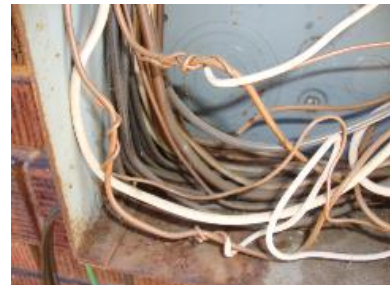
Anti oxidant recommended on aluminum 220 volt connections. Damage/defects noted where ground wires are improperly connected and white hot wires are twisted onto ground wires. Knock-out covers are missing at panel cover. Romex jacketed wires are improperly over-bundled into conduit pipe. Open ended unconnected circuit wires observed. Corrosion observed at panel housing. Panels are without the benefit of complete labeling. Have a licensed electrician make further evaluation and corrections as needed.

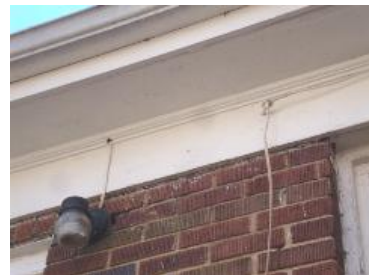
- Aluminum- OK.
- Copper, Damaged/Frayed//Defects noted at interior wiring. "Asbestos" rag type Romex and metal insulated BX wiring should be replaced or updated with modern wiring. Exposed wiring at the exterior should be encased in flex conduit. Have a licensed electrician make further evaluation and corrections as needed. Some abandoned or disconnected wiring is found

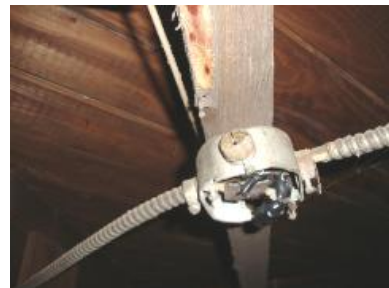
Exposed splices are noted, Junction box cover(s) are missing, Improper wiring is noted. Refer to licensed electrician for review and repair as needed.

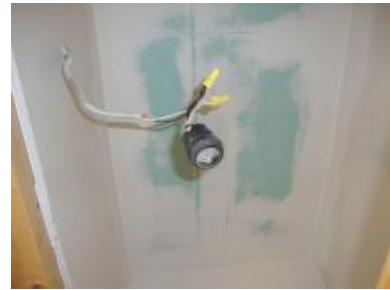
A representative sampling of switches was tested. As a whole, switches throughout the room are in serviceable condition. Improper wiring is noted, Recommend exposed wiring be properly protected. Light fixture missing in closet.

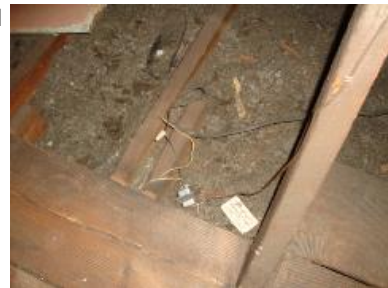
- 
- 
- Damage/Defects noted, Electrical wiring junctions not contained within covered electrical junction boxes are a FIRE HAZARD.: Where electrical wires join each other in areas other than within a closed electrical junction box, a fire hazard exists. Overheating at any exposed wiring junctions could cause a fire which would spread quickly throughout the house. The door bell transformer should be mounted on a non combustible junction box for safety. A licensed electrician should be called out to repair the attic wiring as needed.

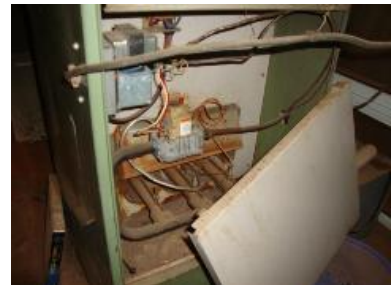
*General Operation & Cabinet:*             Unit did not respond to controls or pilot was not lit. Unable to inspect/No utilities, Furnace is an older unit that has a very limited service life. Corrosion is noted. Contact a licensed heating contractor for further evaluation and repairs as needed.

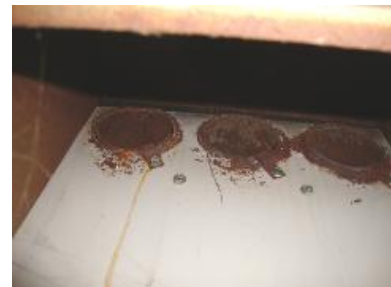
*Burners / Heat Exchangers:*             Indications of burner and/or ignition problems noted due to heat exchanger corrosion. Contact a licensed heating contractor for further evaluation and repairs as needed.

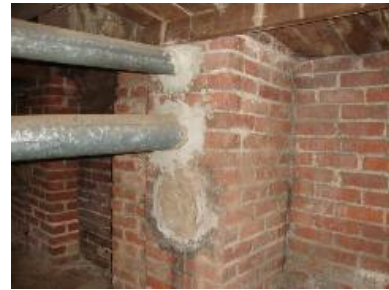
- The flue pipe is metal and enters a masonry flue. During this inspection it is impossible to determine the condition of the interior of the flue. The interior of the flue may be deteriorated, but during a visual inspection we were unable to see the interior walls. There is a Furnace installed without the appropriate steel liner installed to accommodate the cooler exhaust gas temperature. Failure to install the correct steel liner can cause damage to the masonry stack the furnace feeds into. The furnace/boiler flue as installed needs immediate action. An unsafe condition exists, and it is a possible health hazard. Inadequate clearance from the ductwork also observed, which is a fire safety concern.

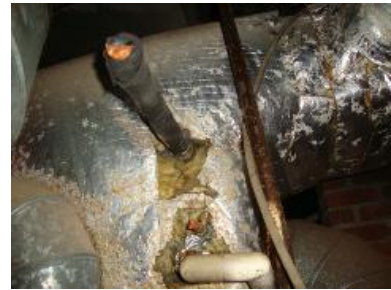
- Unit is older and has a limited life remaining. **Observations- Refrigerant suction lines have been cut and removed by vandals. System is in need of major repairs or replacement.**

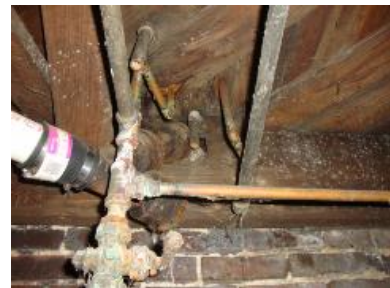
Galvanized. Excessive corrosion is found at some sections, Repairs will be needed. Galvanized water lines rust from the inside out and become restricted over time. If low water flow is detected when the water is turned on, some restriction may have occurred. We recommend further review for possible repairs or replacement by a licensed plumber prior to closing property.

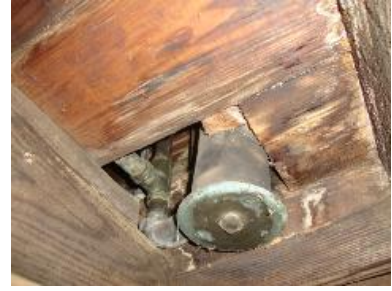
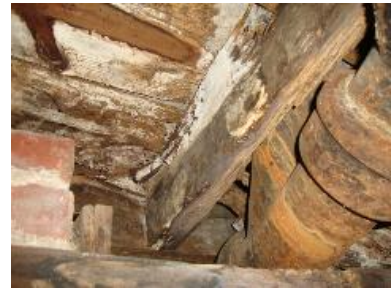
Cast Iron and Lead. Plastic. Damage/Defects were noted in the form of rust & corrosion. Drum type traps observed. These type traps are no longer used due to serviceability problems, including the ability to snake or clean out. Drums traps to be updated and replaced. Water off; not tested. The sewer drain cleanout cap at the front yard is missing. A few updates observed. The main drain from the house appears to be updated.

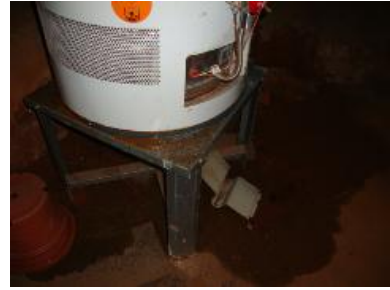
- 
- 
- Unit is located in the basement, Damage/Defects noted, Leakage has occurred, There is evidence of dried water on the side of the tank and below. This generally indicates the tank may be starting to leak. This condition will not get any better. A replacement water heater will be needed soon. Pressure relief valve copper pipe and gas pipe supply have been cut and removed.

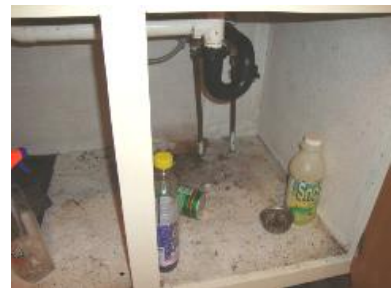
Counters & Cabinets:    Shelf under sink has water damage.

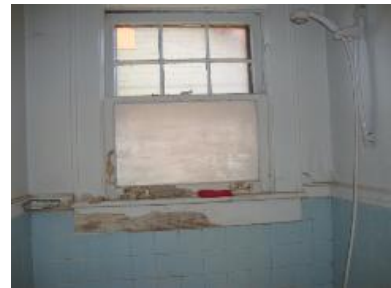
Master Bath And Hall Bath               **Observations-**   Damage   and  
Deterioration is noted at tiled  
shower walls.

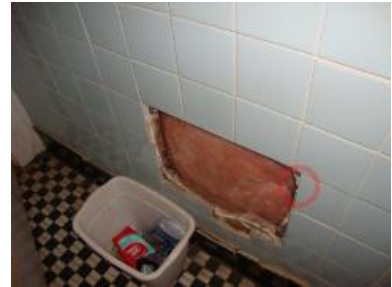
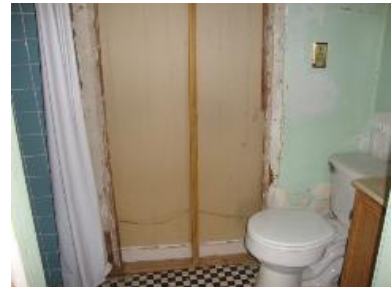
Hidden Damage - The cracks in the walls may be an indication of hidden structural problems. Further investigation as to the cause is needed. Hole also noted.

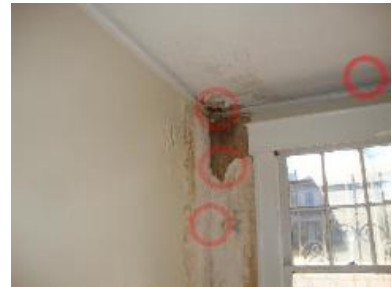
There is evidence of a stain or repair on the wall caused by a prior moisture leak. Hidden Damage - The cracks in the walls may be an indication of hidden structural problems. Further investigation as to the cause is needed.

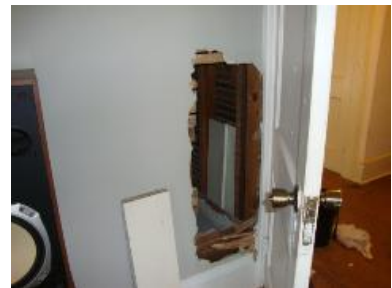
Movement cracks were noted. Determination of the cause and repairs are needed.

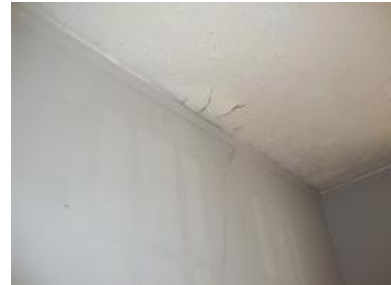
There is some cracking noted. Be sure to take note of any future movement. Most cracking is due to settlement of the construction materials.
