## **Confidential Inspection Report**

**21 Pleasant Avenue  
Greenville, SC 29607**

**Prepared for:  
Mr. and Mrs. Home Buyer**

November 30, 2011 10:00 AM.

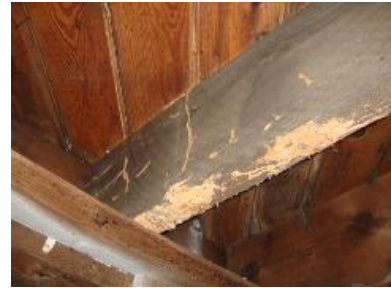
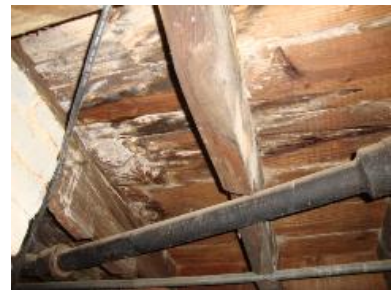
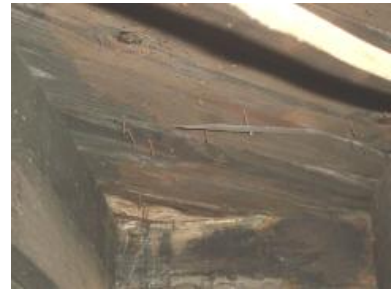
- Floor:*    Soil, Concrete, Remove wood debris and trash from the area, Symptoms of prior water entry exist.
- Posts/Piers & Columns:*    Support posts are brick and wood.
- Windows:*    The windows are cracked or damaged. Some of the foundation vents are damaged.
- Other Observations:* Expansive soils are present in this area. Movement of the house structure may be expected during excessively wet or dry periods of weather.
